**Workshop Tips & Tools:
TPE Boots**

**> SPIDAN TPE boots: the original
from the technology leader**

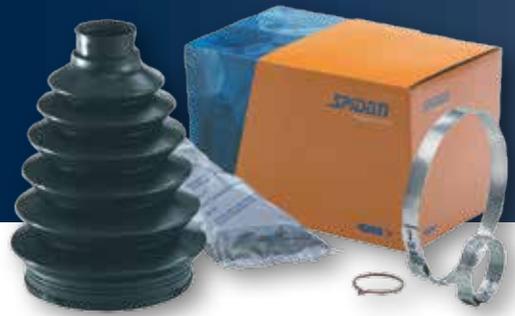
The sealing system of a CV-joint is the most susceptible product within the driveshaft. At the same time its proper function plays a significant role for the lifetime of the whole driveline system. Therefore no compromises can be accepted regarding its design and material selection.

GKN's TPE boots are designed to fit perfectly on the OE shaft as well as on the OE joint. Clamps of stainless steel which have to be mounted with a defined torque guarantee their tight fit. That is why in the independent aftermarket GKN's SPIDAN TPE Boot Kits are the perfect and most reliable repair solution.

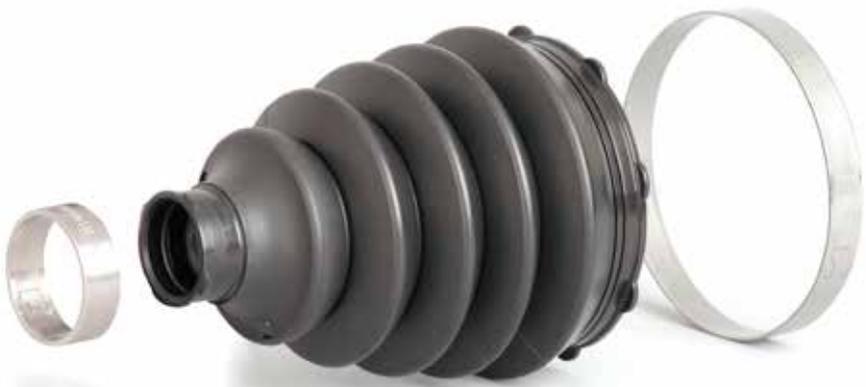
SPIDAN TPE boots are the consistent further development of the well-known rubber boots for CV joints. They are capable to fulfill the increasingly complex demands on today's driveline systems reliably.

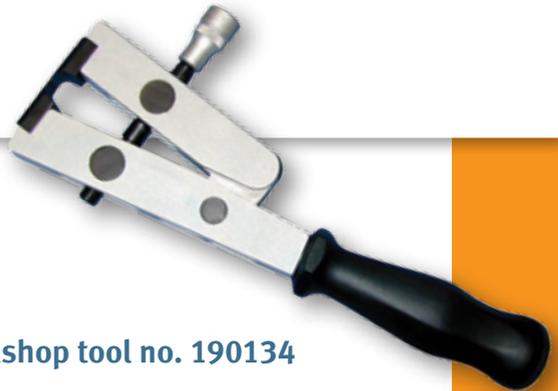
Workshop tool no. 190134

Use this special tool for tightening stainless steel clips on driveshafts. It assures compliance with the torques specified by the car manufacturer.

SPIDAN TPE boots are fixed with boot clamps of stainless steel which require a special torque of 23-30 Nm, depending on the car manufacturer.

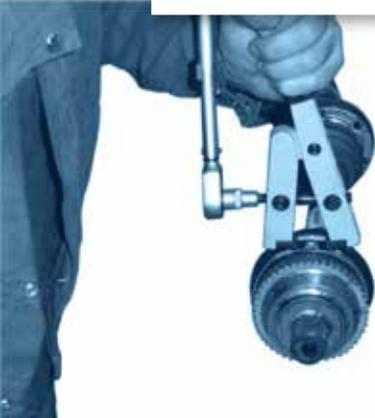
Stainless steel boot clamps

Replacement clamps are available in packaging units of ten pieces per clamp size (Art. No. 190820-190839).
