# GKN TPE Boots

# No Alternative! GKN TPE Boots

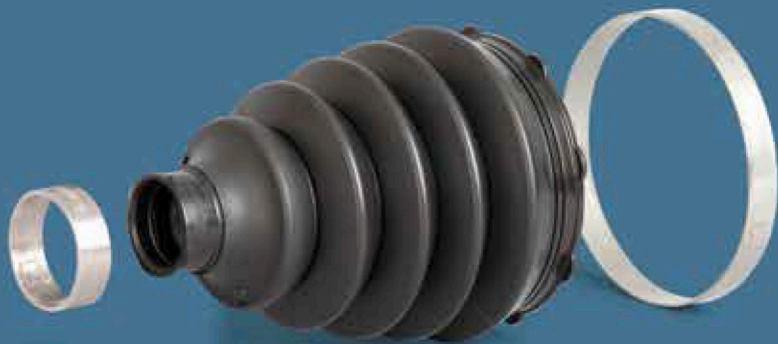
A TPE boot cannot securely protect the joint without secure fastening options. GKN TPE joint boots therefore come with stainless-steel clamps that guarantee firm, durable location.
